# Permeation Grouting of a Subsidence Impacted Watercourse in the Southern Coalfields

G Price, Pointe Engineering Pty Ltd  
B Blacka, SCT Operations Pty Ltd  
N Le Baut, Tahmoor Coal

Myrtle Creek has been impacted by the subsidence associated with longwall mining at Tahmoor Coking Coal Mine in Picton, NSW. Specific impacts are fracturing of the rock bed resulting in a reduction in surface flow and pool holding capacity behind the rock bars that are a characteristic of waterways in the southern coalfields.

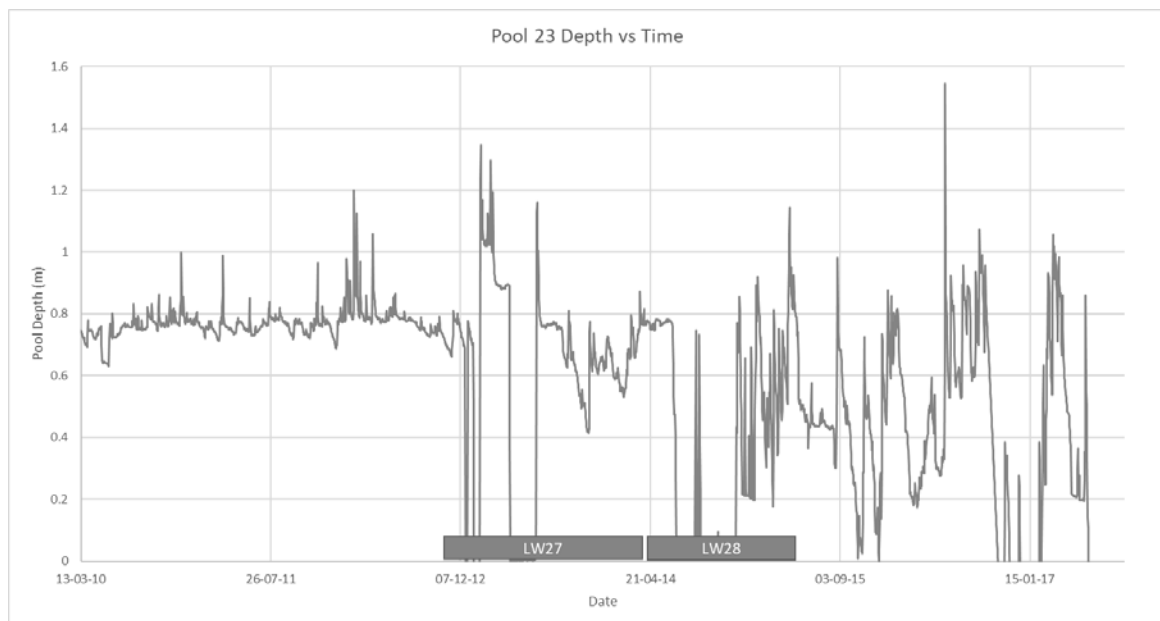
The depth of water in Pool 23 reduced, and remained low after longwall mining occurred beneath the pool.

A pressure transducer was installed in Pool 23 in 2010 to record pool depth. Figure 5 illustrates the pool depth over time. Monitoring started prior to longwall mining in the vicinity of the site. The pool depth remained consistently around 0.8m above the sensor, from installation in 2010 to late 2012.

The pool holding capacity had a notable reduction in late 2012 and again in mid 2014 which aligns with the timing of the longwalls being mined adjacent, and beneath the creek.

The data indicated that pool standing water levels were no longer maintained, except for a short period after significant storm runoff events (Tahmoor Coal, 2017). Rainfall data was also monitored for the area.

**Figure 5 Myrtle Creek Pool 23 surface water logger prior to remediation.**

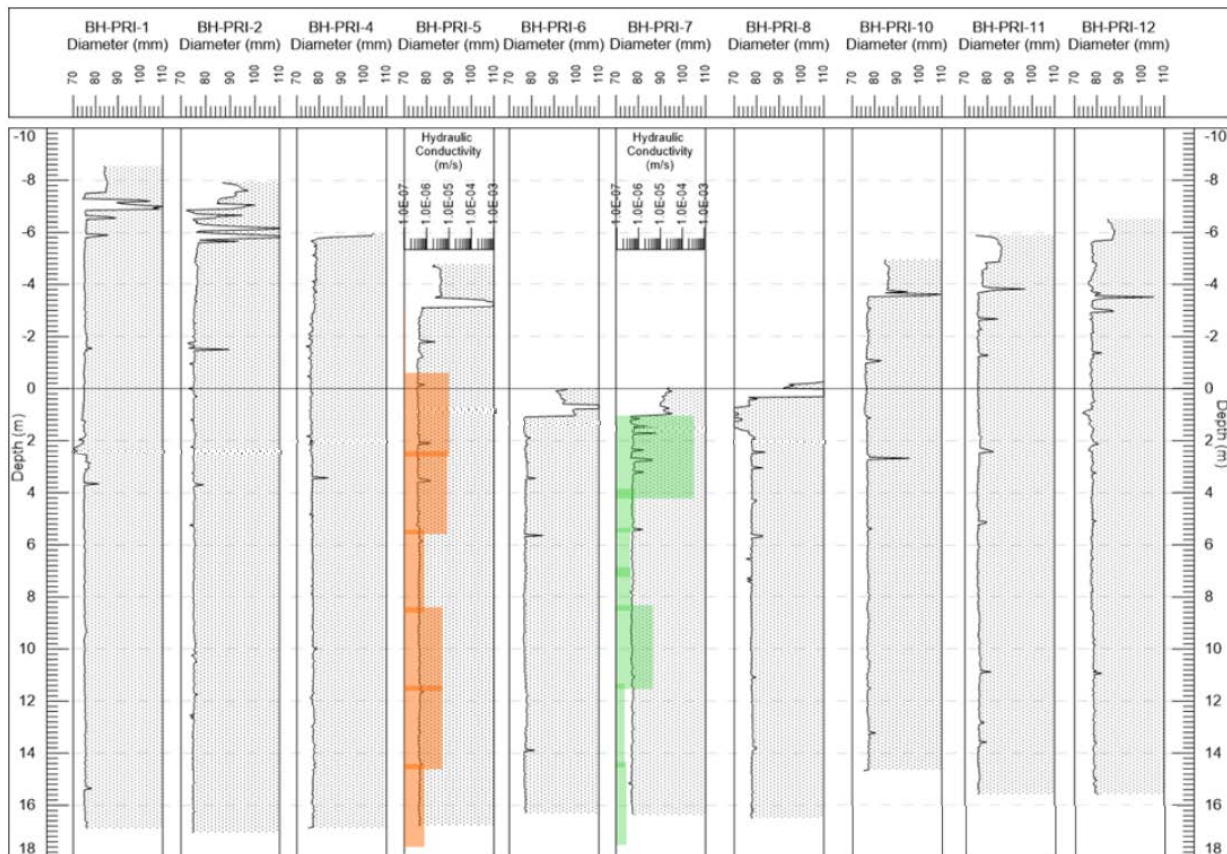
Two boreholes were tested for hydraulic conductivity and suitability for grouting using a constant pressure step injection test. This test is also referred to as a Lugeon Test. The results illustrated in Figure 6 (shown in orange and green bars) show a reduction in hydraulic conductivity with depth. The tests undertaken in the centre of the creek and near to surface gave very high hydraulic

conductivity values. Specific values could not be calculated as they were above the working range of the test. The testing showed that all sections tested were economically groutable with Lugeon values greater than 1 uL (Houlsby, 1976).

The caliper survey was conducted in all boreholes across the creek. Testing results are presented in Figure 6. The distribution of large fractures reducing with depth, as described in Section 2 above, was also confirmed from testing. The caliper survey identified the reduction in fracture apertures with distance horizontally from the centre of the creek.

The characterisation of fractures within the core identified the target fractures for grouting. The sub horizontal bedding planes of between 0° and 15° from horizontal characteristically had some large apertures varying from 5mm to 100mm with no infill. The sub vertical fracture set were generally closed.

**Figure 6 Myrtle Creek Pool 23 caliper survey and Lugeon testing (Strata Control Technology).**

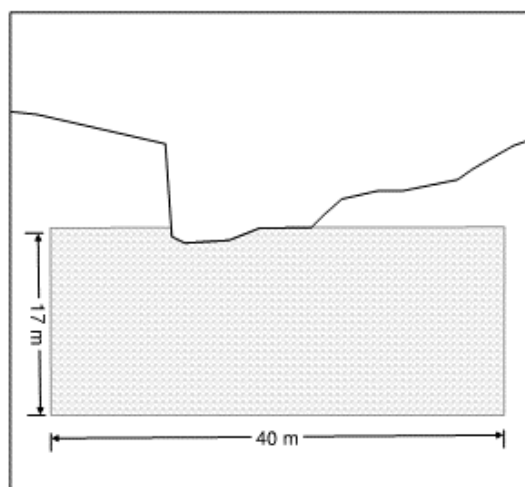
**Figure 7 Sketch illustrating the cross section of the grout curtain.**

The layout of drilling used enabled the grout to form a low permeability subsurface feature. At Pool 23, the layout suiting the conditions and purpose was a grout curtain. A grout curtain involves a row (or multiple adjacent rows)

of drill holes injected with grout as presented in Figure 7 and Figure 8.

The drilling process at Pool 23 involved a series of boreholes perpendicular to the flow of the creek and in alignment with the controlling rock bar. Boreholes were drilled with a purpose-built man portable drill rig. The row of boreholes extended 20m from the centre of the creek up both

embankments as represented on Figure 7 and Figure 8 below. The boreholes were drilled to 17m below the existing ground/creek level following the review of the ground characterisation data.

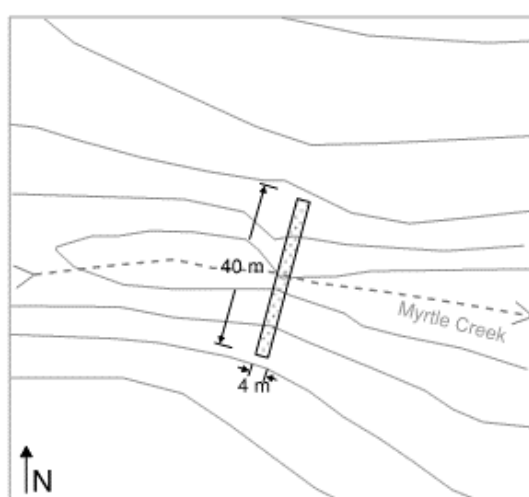
**Figure 8 Sketch illustrating the plan view of grout curtain alignment.**

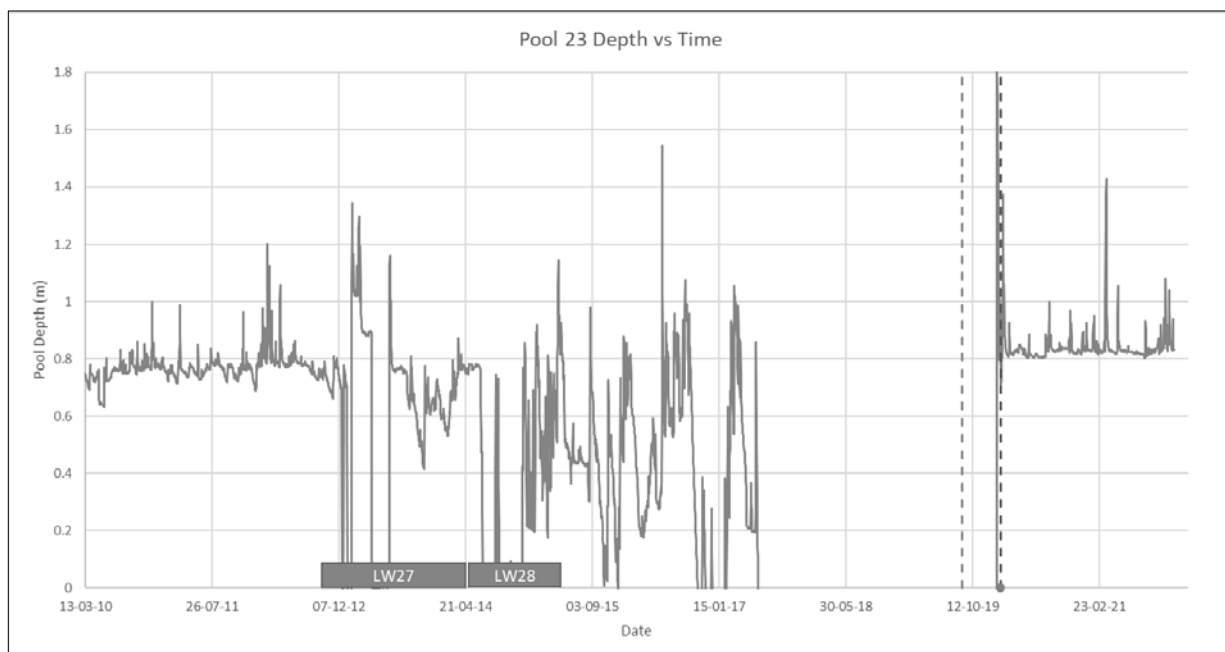
The pressure transducer installed in Pool 23 in 2010 showed the depth of water had reduced and remained low after longwall mining occurred. The grout curtain was completed in January 2020 and Figure 9 shows a graph illustrating the pool depth prior to and post construction. No monitoring data was recorded between mid 2017 and when grout remediation works began.

The pair of dashed vertical lines in Figure 9 indicate the construction period of the grout curtain. The pool depth has consistently remained 0.8m above the sensor. From visual observations the pool filled during a rain event in February 2020 and has remained full and overflowing to the date of writing this paper. Figure 10 and Figure 11 show the pool before and after remediation respectively.

**Figure 9 Myrtle Creek Pool 23 surface water logger prior to and post construction.**

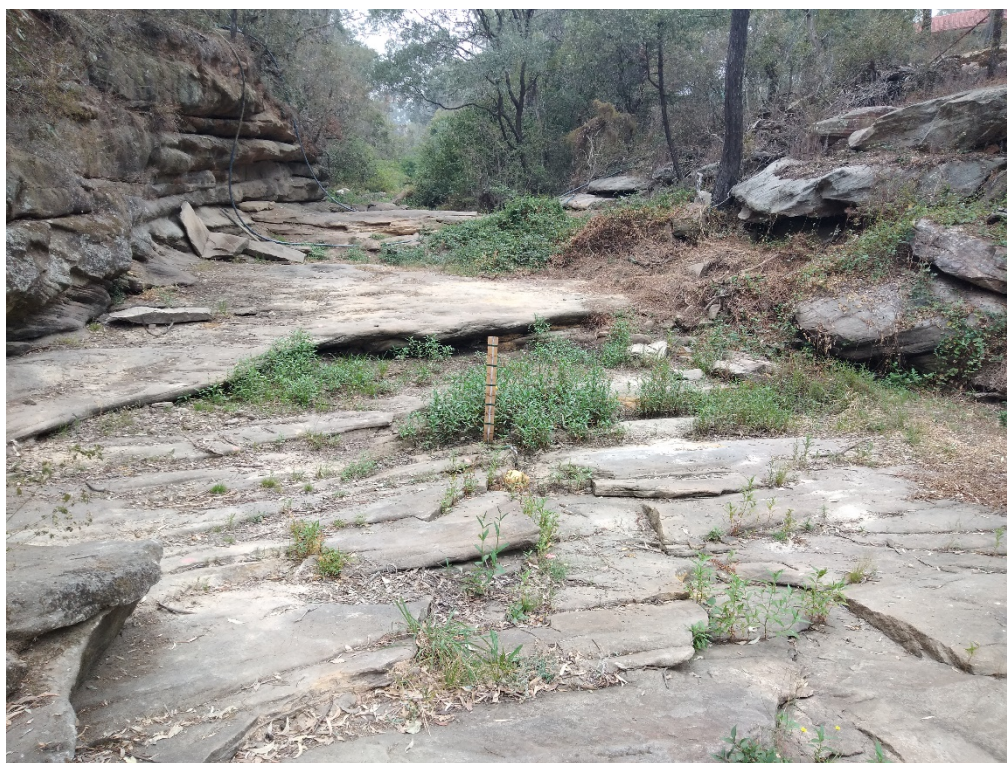
Subsidence impacts at Pool 23 have been recorded as fracturing at the base of the creek channel, reduction of water flow and reduced pool holding capacity.

**Figure 10 Pool 23 prior to remediation in September 2019.**

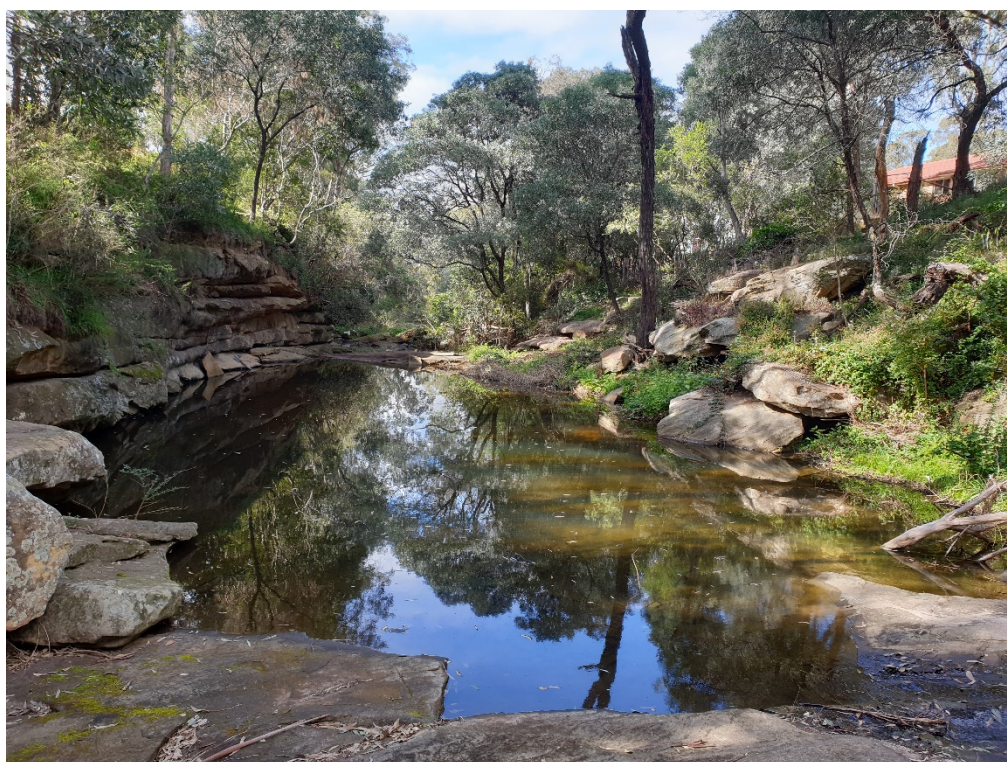
Pool 23 has been holding water and has been overflowing since completion of the works in early 2020.

**Figure 11 Pool 23 post remediation in February 2022.**
