DETERMINATION OF LOAD TRANSFER CHARACTERISTICS OF GLOVED RESIN BOLTS FROM LABORATORY AND *IN SITU* FIELD TESTING

Dion Pastars, *Geotechnical Engineer*
Huntly East Mine, Solid Energy New Zealand Ltd
Huntly, New Zealand

Stuart MacGregor, *Director*
SCT Operations Pty Ltd
Wollongong, NSW, Australia

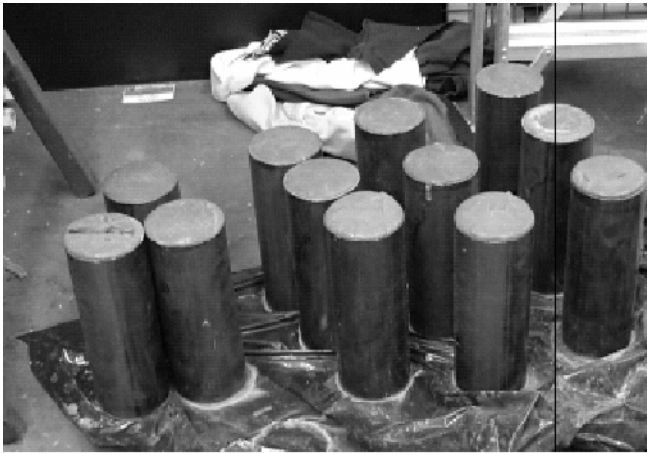
Fig 3: High strength grout cylinders used for laboratory pull testing after pouring.

Figure 3 details the completed test cylinders prior to surfacing (to provide a flat bearing surface) and drilling of the 27mm diameter bolt hole.

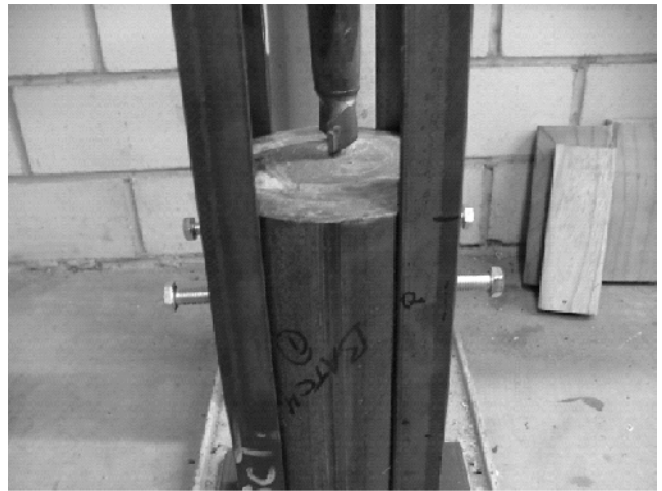
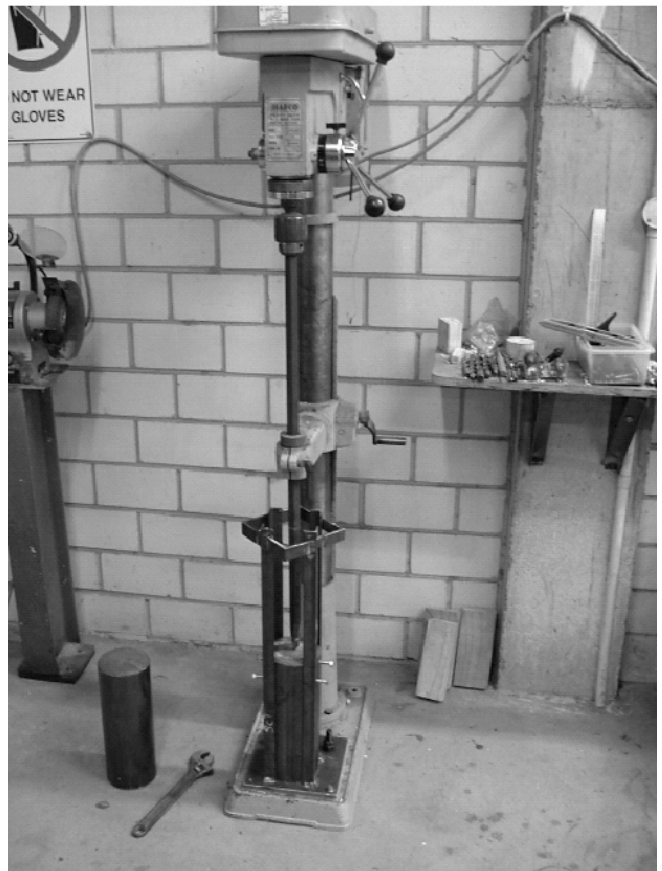
Fig 4: General arrangement of drill stand showing alignment jig, drill steel and 27mm ø bit.

Drilling the Hole - The bolt hole was drilled using a standard 27mm EP tungsten carbide wing bit and 22mm hex drilling rods. To provide repeatability on each hole, a test jig was constructed for use with a commercial drill stand as shown in Figure 4. The drill stand enabled a constant drill speed (approximately 400 RPM and similar to the hand held pneumatic bolters used underground) and alignment of the cylinder and drill steel. Samples were wet flushed during drilling then thoroughly flushed with water and dried with compressed air to remove any residual cuttings.

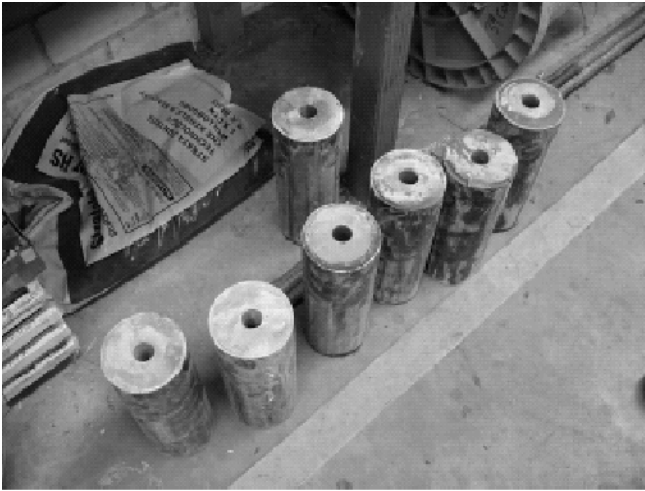
Fig 5: Test cylinders prior to installation of bolts.

Figure 5 details the completed test cylinders with the ends faced for final testing.

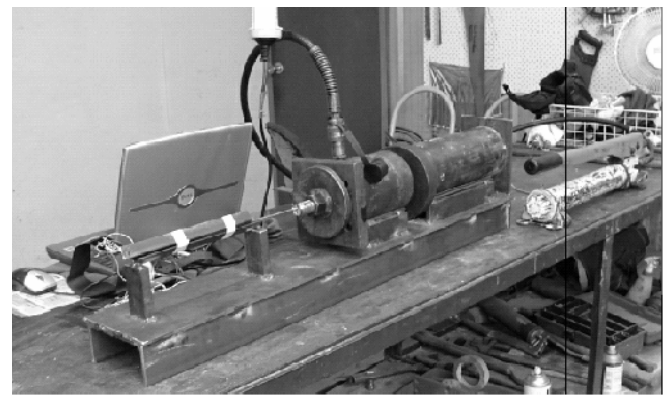
Fig 6: General arrangement of laboratory pull testing apparatus.

A pull testing jig was constructed to ensure alignment of pull testing cylinders and the testing apparatus. Figure 6 details the general arrangement of the pull testing apparatus showing:

- Test frame;
- Test cylinder;
- Hollow ram jack (30T);
- Hydraulic pump;
- Linear Potentiometer;
- Pressure Transducer; and
- Laptop and interface.

Samples were placed into the test frame and load applied incrementally via the hydraulic pump for a total test duration of approximately 5 minutes. As well as real time display, the process was logged to file with LABVIEW for later processing.

The pressure transducer had a safe working limit of approximately 180-200kN, which is just below the yield strength of the CVX bolt (240kN). During testing, samples were loaded to post failure of the bolt/resin/gloving system or a maximum of 180-200kN.

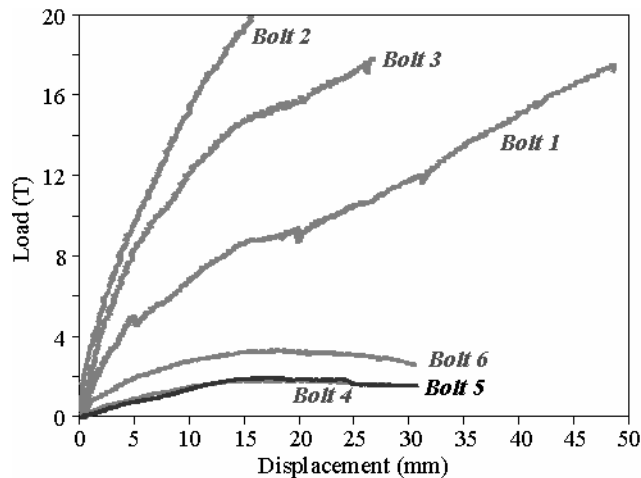
Fig 7: Load versus displacement for the six laboratory tests on 300mm encapsulation.

Figure 7 details the logged raw system displacement and load for each test.

Bolts 1 and 3 were tested to a load of 182kN and 183kN respectively, with indication of the system being near peak capacity. Failure was along the resin/grout interface. Bolt 2 was tested to a peak load of 203kN and whilst it was obviously failing along the resin/grout interface, had not reached its peak load.

Bolts 2 and 3 showed very similar system stiffness, particularly in the 0-100kN range. Bolt 1 showed a somewhat softer response, although still maintained a similar load.

As shown in Figure 7, system response from all of the gloved bolts was very similar. Peak loads were: 20kN (Bolt 4), 22kN (Bolt 5), 36kN (Bolt 6). Failure on all bolts was along the tri-laminate/grout boundary. Peak load was developed at approximately 15-16mm displacement.

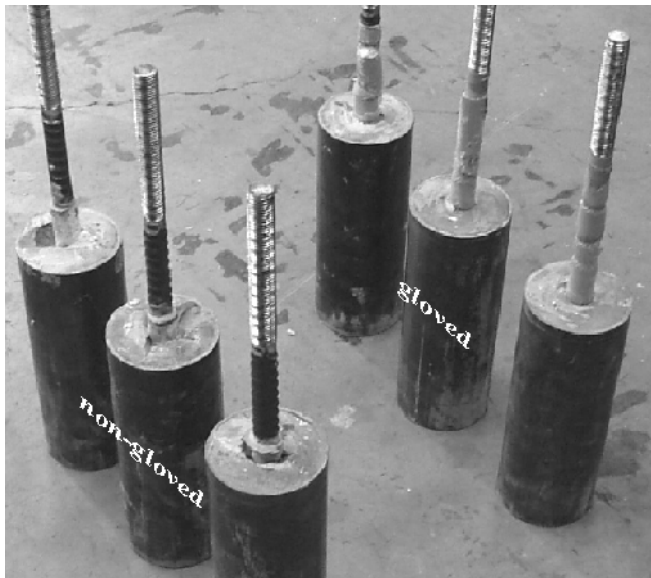
Fig 8: Tested samples showing failure along resin/borehole wall interface.

Figure 8 details the six bolts following testing indicating the general mode of failure along the resin/bolt hole-wall interface.

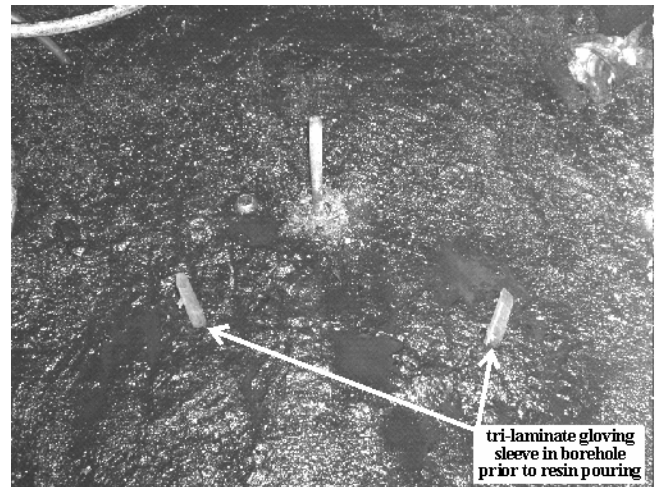
Fig 9: General arrangement of field test site showing gloving cartridges prior to resin pouring and bolt installation.

Figure 9 details the general arrangement of the site showing the two “empty” cartridges in place awaiting resin pouring.

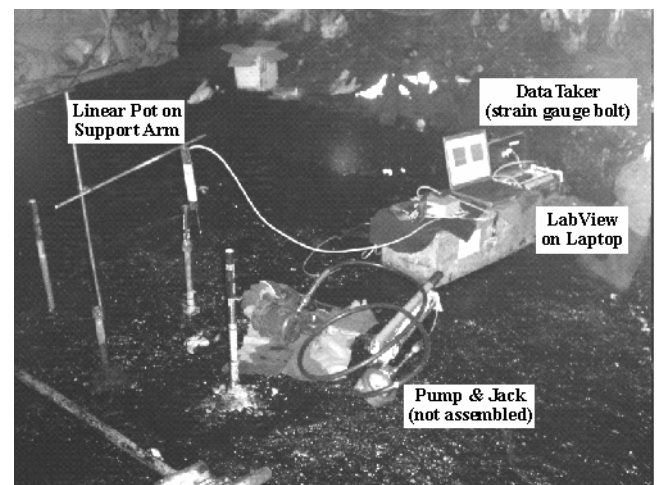
Fig 10: Arrangement of field testing apparatus with jack/pump, displacement plus load measurement and strain gauge logger.

Figure 10 details the general testing arrangement with the full assembly shown. Displacement was measured using a support arm from a specifically installed standard bolt in the floor adjacent to the test bolts. The support arm was able to be rotated about several axes to ensure alignment with the test bolt.

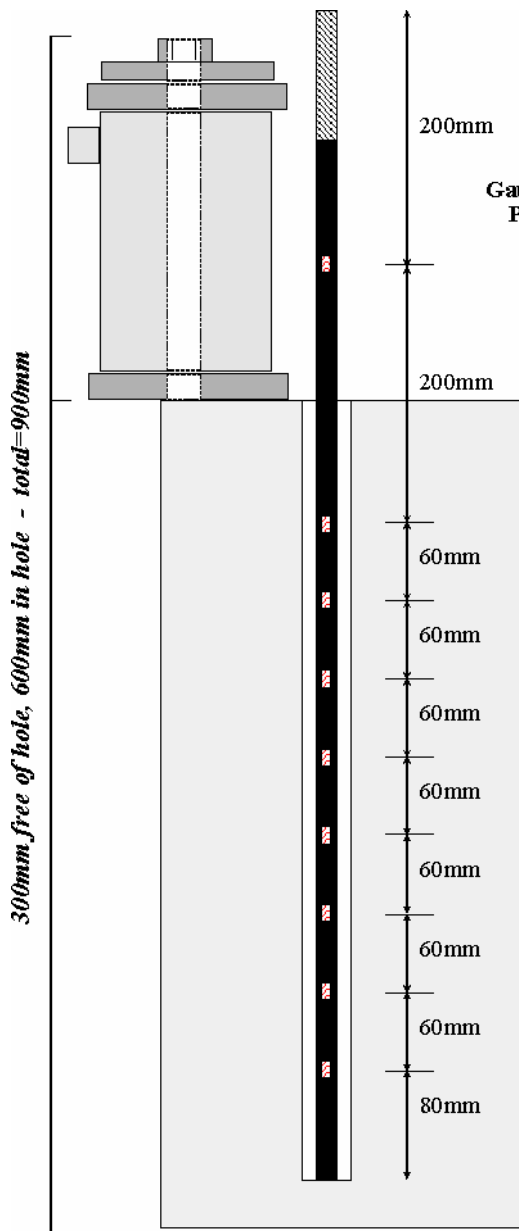
Fig 11: General arrangement of gauges on bolt relative to test set-up.

Figure 11 details the arrangement of the strain gauged bolts relative to the overall testing setup, indicating the high density of gauges along the bonded length.

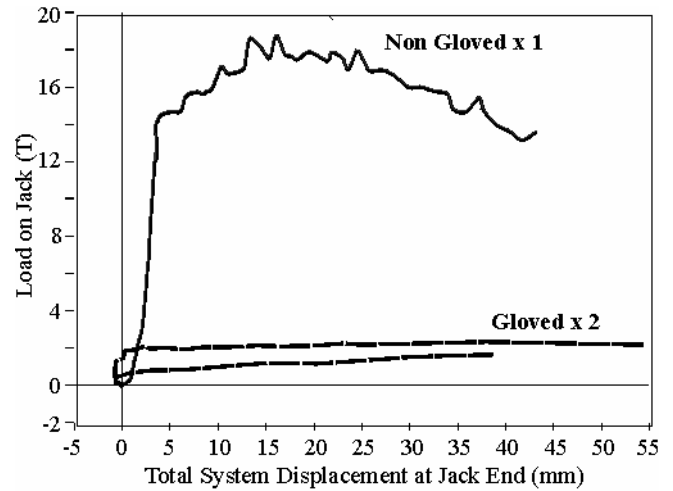
Fig 12: Load versus displacement for 3x600mm CVX bolts in coal.

Figure 12 details the raw system displacement and jack load for each of the three tests.

The two gloved bolts exhibited very similar, poor, performance. Peak loads were less than 20kN on both bolts and were very consistent with the laboratory results. The load was maintained at a generally consistent level throughout the testing period.

As shown in Figure 12, the non-gloved control bolt displays the characteristic form of a standard short encapsulation pull test. Following initial stiff performance, where load reached approximately 145kN after 3mm displacement, system stiffness reduced with the peak load of 187kN developed at approximately 19mm of displacement.

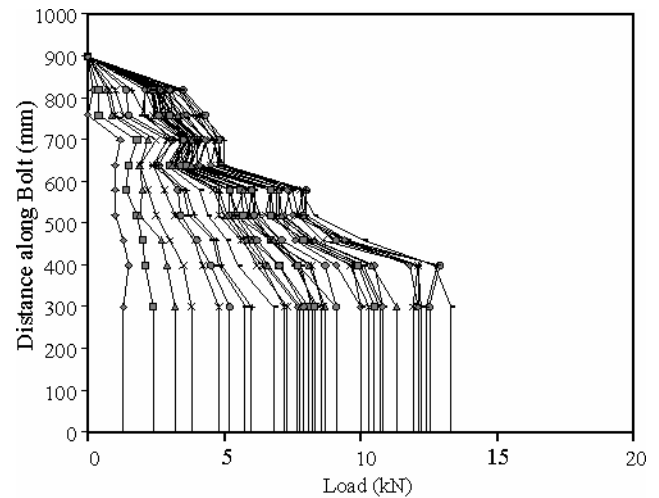
Fig 13: Bolt loading profile for gloved bolt (344) showing progression of load generation.

Figure 13 details the distribution and generation of bolt load along the profile for gloved Bolt 344. Note that in this configuration, the bolt is encapsulated from 300-900mm, with 0-300mm being the section proud of the collar. Figure 13 shows that load was generated along the bolt, indicating contact of the bolt system with the ground along the bolt, for most of the encapsulated length. Only the section from 760mm-820mm does not show any load transfer from the commencement of pull testing. Some other sections of the bolt showed that as load is developed, peak shear stress is achieved and no additional load can be taken over that section – this is apparent over the 520-580mm, 640-720mm and 300-360mm sections of bolt as testing progresses.

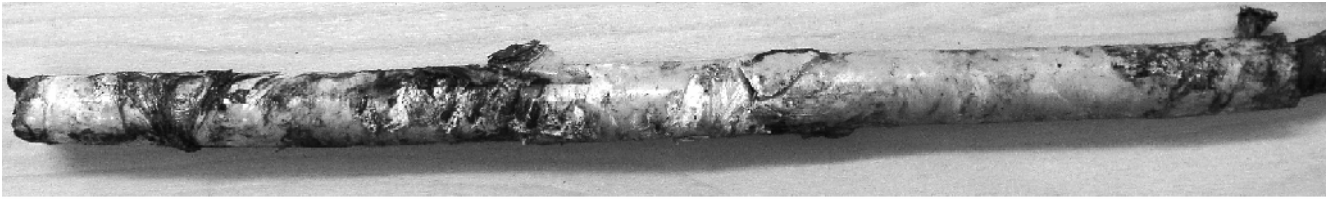
Fig 14: Overcored bolt 344 showing well mixed resin, presence of gloving on outer surface.

The encapsulated sections of overcored bolt (that were not removed when sawn off at the collar) are shown in Figure 14. The bolts exhibit very good resin mixing and setting (as would be expected with the mix and pour resin). The gloving is generally intact about the bolt and shows evidence of being displaced relative to the bolt hole wall. Measurement of the resin column diameter using a vernier calliper shows that the diameter is variable and would appear to have conformed to the hole size – again indicating contact of the tri-laminate film with the bolt hole wall. Measured resin diameters for each gloved bolt were:

Gloved Bolt ID	Measured Resin Diameter at Distance from Base of Bolt			
	100mm	200mm	300mm	400mm
342	29.0	29.4	28.4	
344	30.6	30.4	30.1	29.8

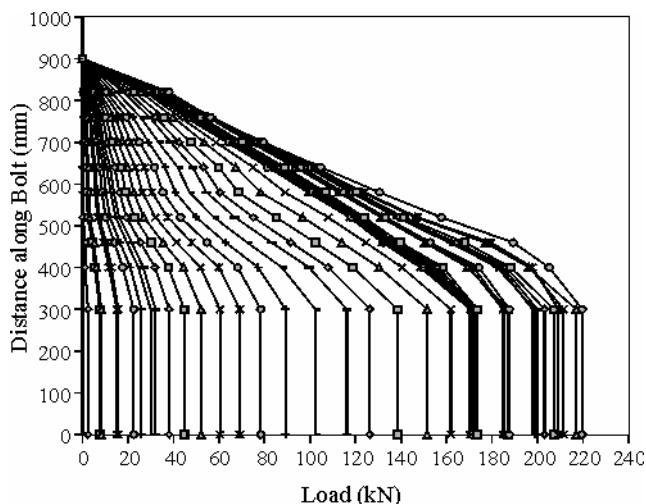
Fig 15: Bolt loading profile for non-gloved bolt (343) showing progression of load generation.

Figure 15 details the distribution of bolt load from the strain gauge results indicating the control bolt is encapsulated along its entire length.

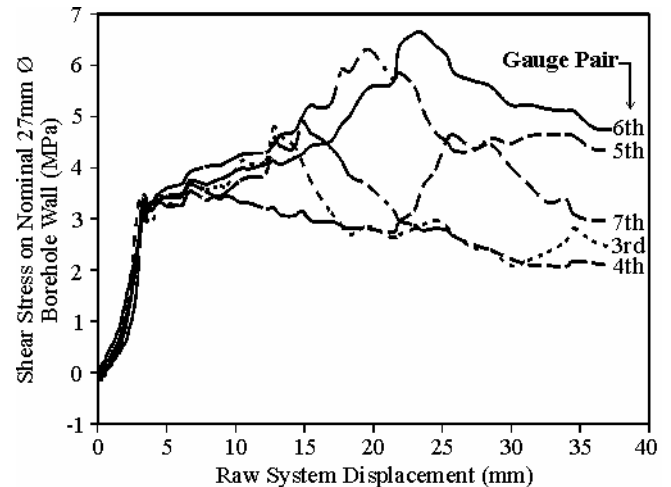
Fig 16: Calculated shear stress on borehole wall (27mm Ø) at locations along instrumented non-gloved bolt showing components of work done at different locations and time.

The strain gauged control bolt provides an insight into the nature of load generation in a standard fully encapsulated bolt. To analyse the contribution of each part of the bolt, each gauge pair was reviewed to determine the amount of work done (as a measure of shear stress). Figure 16 details the calculated shear stress on the bolt hole wall versus system displacement (gauge pairs at the collar and bottom of bolt not shown due to possible end effects from free surface and bolt end).

The results show that the style of behaviour is very consistent over the initial stiff period of load development. All gauge pairs show a similar capability to sustain load, in the order of 3MPa shear stress on a 27mm diameter bolt hole. At this stage, the peak load at the collar is approximately 140kN (refer Figure 15). After this stiff behaviour, the contribution of load at each point along the bolt is markedly different, although following a consistent trend.

The trend is one of increasing shear stress that reaches a peak sustainable load by the coal/resin interface (the weakest link in the coal/resin/bolt system) which then rolls over to a lower, sustained residual shear stress. The progression of this trend is also consistent, and migrates from the collar (area applied load) towards the back of the bolt. This is obvious in Figure 16 as a “wave” of peak shear stress passing progressively through gauge pairs 3, 4, 5, 6 and 7. At any one point in time, the load capacity of the bolt is the weighted average of the individual contributions. Therefore, whilst locally shear stresses are in the order of 7MPa, the weighted average is typically 4-4.5MPa, which is consistent with the peak loads measured.
