Geotechnical aspects of the Pike River mine drift recovery

GEOTECHNICAL ASPECTS OF THE PIKE RIVER MINE DRIFT RECOVERY

Chris Lee¹, Stuart MacGregor² and Dinghy Pattinson³

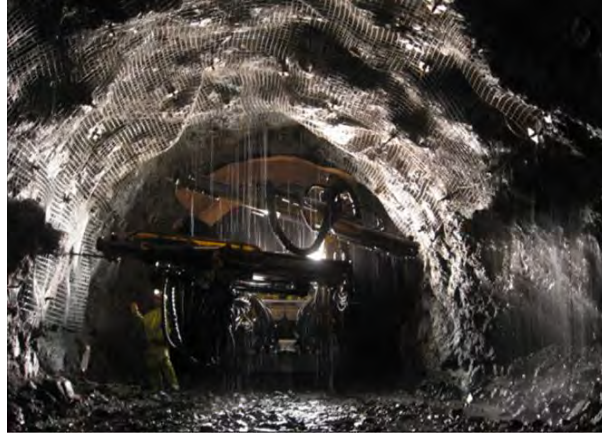
Figure 3: Pike River drift during construction highlighting the ground conditions, water inflows and often-wet conditions

handling infrastructure - this area is known as the Pit Bottom in Stone. The tunnel profile in the pit bottom in stone varied to suit the installed infrastructure with resultant profiles ranging from 5.5 m to 8m wide and from 4.5 m to 11 m high. The drift was constructed almost entirely by conventional drill and blast methods using a twin boom jumbo and conventional explosives. Figure 3 shows the jumbo in the drift highlighting the typical tunnel profile, water inflows and the often-wet tunnelling conditions.

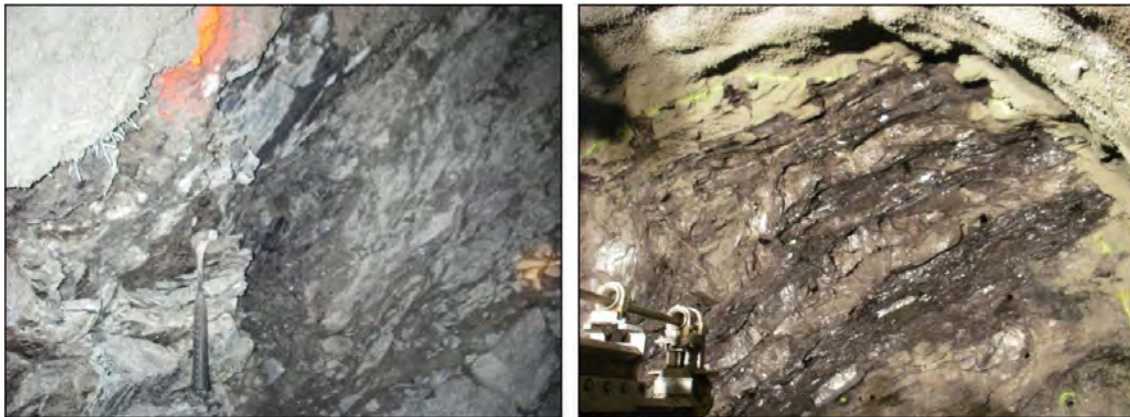
Figure 6: Paparoa Coal Measures east of the Hawera Fault showing the typically weak and tectonically deformed nature of the ground

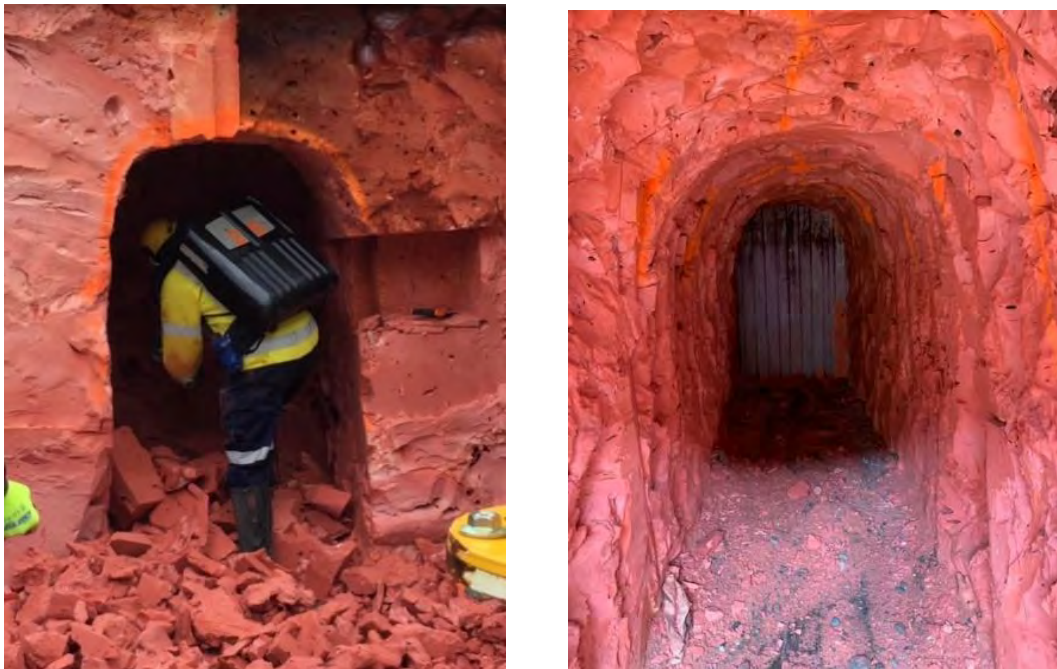
Figure 9: Tunnel excavation in shipping container wearing BG4 using hand saw, pelican pick and spade (left) and completed tunnel showing profile (right)

As part of small tunnelling field simulations, a small tunnel was excavated through Rocsil that had been pumped into a 6 m (20 ft) shipping container on surface between 12 and 13 March 2020. The tunnelling trial was conducted to simulate the proposed excavation geometry and methodology to be used underground during the Rocsil plug breach. This involved two workers using BG4 breathing apparatus to advance a small tunnel of 1.0 m width and 1.8 m height with an arched roof profile using hand tools. The trial geometry is the planned excavation size to be used when tunnelling through the Rocsil plug. The Rocsil material was easily excavated using a hand saw, pelican pick and spade with excavated material initially loaded into a skip and subsequently wool bags to simulate the proposed handling and storage methods underground. The approximately 6 m long Rocsil tunnel was fully excavated quickly, in around 4hrs, given the very weak material strength (average 60 kPa), easy cuttability and very low density (37 kg/m³) which made for efficient material handling. A bulking factor of around 1.5 was estimated from the trial. Figure 9 shows the tunnel being excavated through the shipping container and the tunnel at completion.

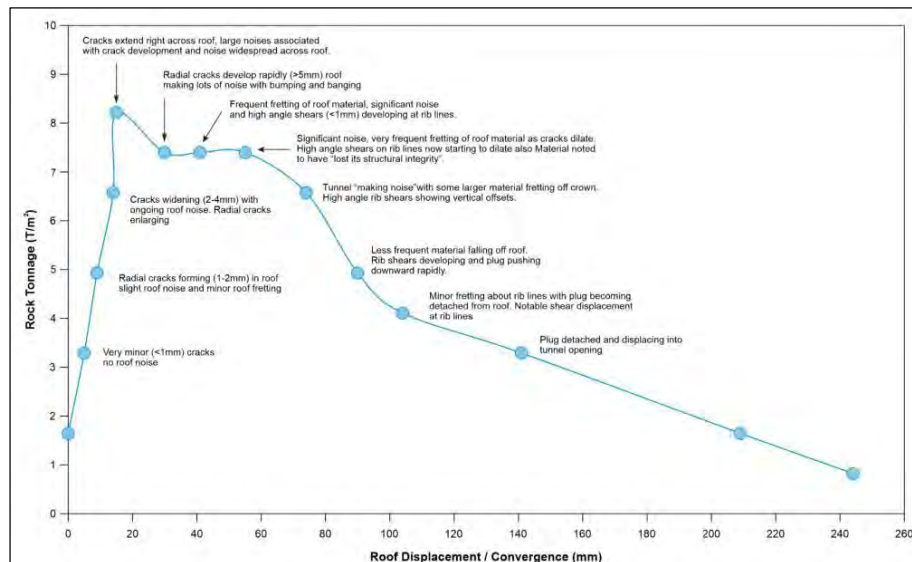
Figure 11: Tonnage displacement graph highlighting the Rocsil tunnel deformation loading characteristics

The Rocsil foam septum above the tunnel was able to withstand peak loads of 80.6 kPa equal to 8.2 t/m² or 3.1m of rock head (dead weight loading) at around 15mm convergence. Notably the load – displacement graphs show the tunnel roof septum was able to sustain relatively high residual loads, following peak load being obtained, for reasonably large displacements. High residual loads of approximately 72.5 kPa were maintained to 55mm of roof convergence. Following this the load (strength) of the material dropped off very quickly with high angle shears observed on the rib lines and a "loss of structural integrity" noted during the test. The results suggest that the Rocsil material is able to resist load post peak strength for relatively high levels of displacement but once critical levels of stability are reached (as evident by the development of high angle shear failures) strength is rapidly lost and the load carrying capacity or the Rocsil roof septum is substantially reduced (Figure 11).
