# Impact of Vertical Stress on Roadway Conditions at Dartbrook Mine

*Ken Mills*, Geotechnical Engineer Strata Control Technology Pty. Ltd. Wollongong, NSW, AUSTRALIA

Rod Doyle, Geotechnical Engineer
Dartbrook Mine
Shell Coal Pty. Ltd.
Hunter Valley, NSW, AUSTRALIA

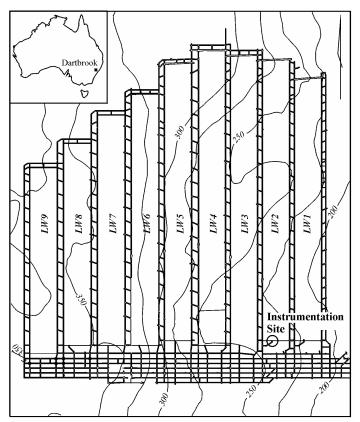
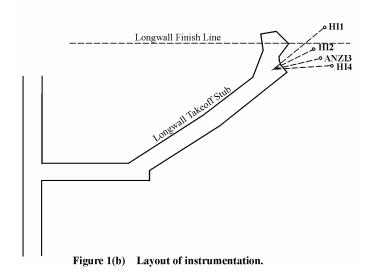
Figure 1 shows a plan of Dartbrook Mine. The mine is currently working a 4m section near the bottom of the 25m thick combined Wynn / Bayswater / Broonie Seam. Longwall panels 200m wide are extracted from north to south. The overburden depth generally increases toward the west ranging from 200 m in Longwall 1 to over 400 m by Longwall 9.

Figure 1(a) Plan of Dartbrook Mine showing location of instrumentation site and overburden contours.

A plan of the monitoring site and the layout of the instrumentation within the takeoff stub at the end of Longwall 2 are shown in the inset of Figure 1. The depth of overburden at the site is 240 m. The average overburden density is  $2200 \text{ kg/m}^3$  due to the high proportion of coal, so the initial background vertical stress at the site is approximately 5 MPa.

An array of four stress change monitoring instruments was installed from the takeoff stub into the coal barrier ahead of (and over) the finish line of the face. Three CSIRO HI stresscells (Worotnicki & Walton 1977) and one ANZI stresscell (Mills 1997) were installed. These instruments measured a profile of stress changes in three dimensions ahead of the face.

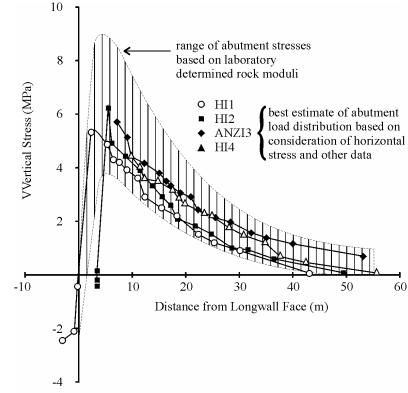
Figure 2 shows a summary of the vertical component of the stress monitoring results. The results indicate an exponential distribution of vertical abutment stress away from the goaf edge. The vertical stress peaks at about 11 MPa at the goaf edge (6 MPa increase plus 5 MPa background). The vertical stress change is less than 1 MPa at 50 m from the goaf edge and is imperceptible beyond about 100 m from the goaf edge.

The area under the vertical stress curve represents the total abutment load. The vertical stress distribution measured indicates a total load of approximately  $140 \ (120\text{-}200) \ MN/m$ .

Figure 2 Results of abutment stress monitoring.

the total load that would be expected on the forward abutment. At the location of the stress monitoring site, the abutment load is estimated to be in the range 135 to 200 MN/m. The measured load fits within this range and gives confidence in the approach used to estimate vertical abutment load from redistribution of overburden weight.

Rib deterioration was observed in the roadways adjacent to the end of Longwall 2 when the vertical stress increased by 1 to 2 MPa. This observation indicates that the in situ, unconfined strength of the Wynn seam coal is in the range 6 to 7 MPa. The more general observation that rib deterioration occurs routinely on development when the overburden depth increases beyond about 240 to 280 m is also consistent with in situ coal strength of approximately 6 MPa.

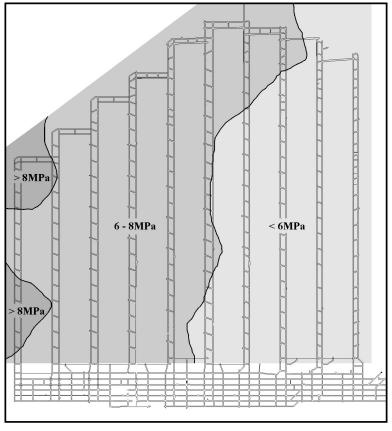
Figure 4a shows the pre-mining vertical stress increasing with depth toward the west.

a) Pre-mining vertical stress on all roadways.

In each case, the contour value represents the maximum stress that would be experienced for the particular stage of mining for that particular roadway. For instance, Figure 4b shows the maximum vertical stress experienced at the maingate corner of each longwall face. The contoured values are only relevant to the maingate roadway. Figure 4c shows the maximum vertical stress experienced under side abutment loading conditions and is only relevant to the roadway adjacent to the maingate. Figure 4d shows the vertical stress experienced by the tailgate roadway under loading conditions from two adjacent longwalls.

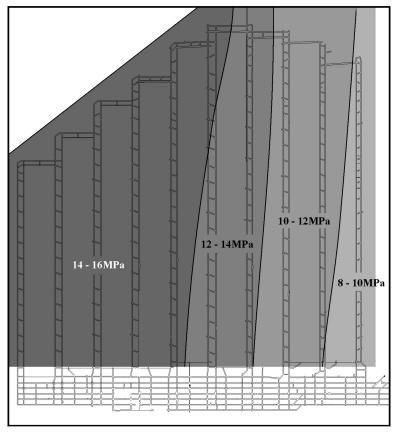
Figure 4b shows vertical stress experienced at the maingate corner of Longwall 1 was approximately 10 MPa for the full length of the panel. As overburden depth increases this will increase to 15 MPa by Longwall 9.

b) Vertical stress at maingate corner of longwall panel.

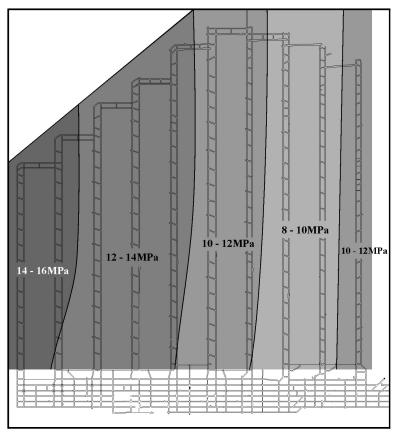
Figure 4c shows that roadway adjacent to the maingate experiences a range of vertical stress from 8 MPa in Longwall 1 to greater than 14 MPa by Longwall 9.

- c) Vertical stress on the roadway next to the maingate under full side
- d) Vertical stress at tailgate corner of longwall panel.

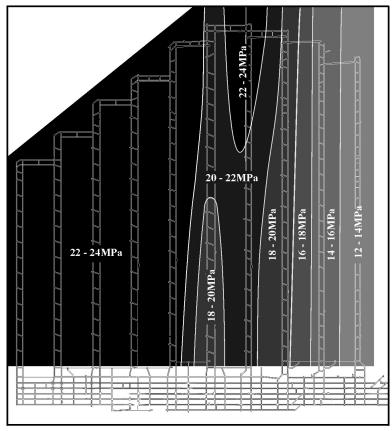
Figure 4d shows that the vertical stress experienced at the tailgate corner was 15 MPa for Longwall 2 and will be 24 MPa by Longwall 9. The wider chain pillar between Longwall 4 and 5 has the effect of reducing the vertical stress in the tailgate of Longwall 5 to less than 20 MPa. From Longwall 6 onward, vertical stress at the tailgate end of the longwall face is consistently higher than 22 MPa.

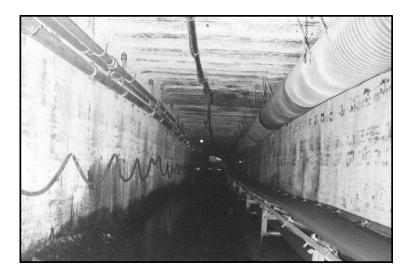
The roadway conditions experienced at various stress levels are shown as a series of photographs. Figure 5a shows roadway conditions typically experienced at less than 200m depth of overburden when there is no inclination of the vertical stress. The rib and roof conditions are excellent.

Figure 5(a) Excellent roadway conditions when major stress is vertical and less than 6-7MPa.

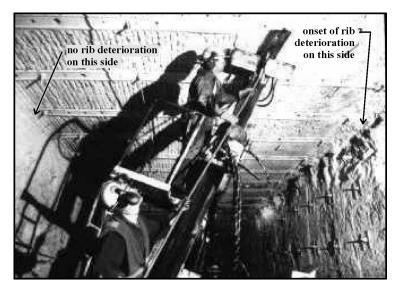
When the vertical stress increases to above 5 MPa, biased rib deterioration (top corner on one side and bottom corner on the other side) begins to become apparent in areas where the vertical stress is inclined slightly from vertical as shown in Figure 5b.

Figure 5(b) Onset of biased rib deterioration above approximately 5MPa vertical stress.

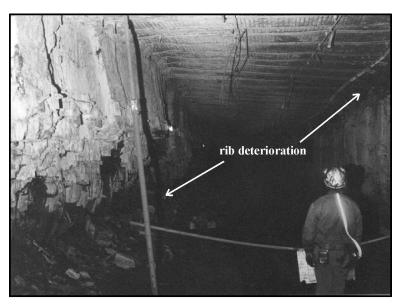
Figure 5c shows the roadway conditions when the vertical stress is approximately 10 MPa. There are consistently high levels of rib deterioration, but the roadways remain serviceable provided adequate rib support has been provided. There is no sign of roof deterioration.

$Figure \ 5(c) \quad Biased \ rib \ deterioration \ worsens \ at \ 8-12 MPa \ vertical \ stress.$

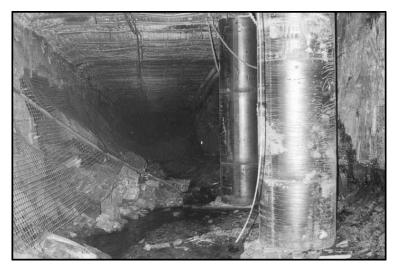
Figure 5d shows the roadway conditions when the vertical stress is approximately 15 MPa. The ribs are beginning to fail as large blocks of sufficient size to make the roadway unsuitable for regular travel. There is still no sign of roof deterioration although some of the straps show signs of shortening, by buckling away from the roof.

Figure 5(d) Rib deterioration threatens serviceability of roadway as a travel road above 15MPa vertical stress.

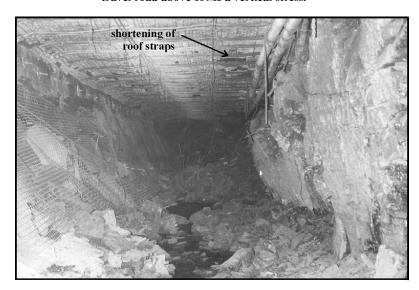
Figure 5e shows the roadway conditions when the vertical stress is approximately 20 MPa. The ribs are broken and rotate in large blocks out into the roadway. Under these conditions, the roadway is barely serviceable and significant secondary support is required.

Figure 5(e) Roadway conditions are severe and potential for roof falls becomes an issue above 20MPa vertical stress.

Above 20 MPa, the Poisson's ratio effect of the increase in vertical stress is in the range 5 to 6 MPa. When added to the pre-existing horizontal stress, the total horizontal stress begins to exceed the in situ strength of the coal and roof failure becomes an issue.
