# Permeation Grouting of a Subsidence Impacted Watercourse in the Southern Coalfields

G Price, Pointe Engineering Pty Ltd  
B Blacka, SCT Operations Pty Ltd  
N Le Baut, Tahmoor Coal

Myrtle Creek has been impacted by the subsidence associated with longwall mining at Tahmoor Coking Coal Mine in Picton, NSW. Specific impacts are fracturing of the rock bed resulting in a reduction in surface flow and pool holding capacity behind the rock bars that are a characteristic of waterways in the southern coalfields.

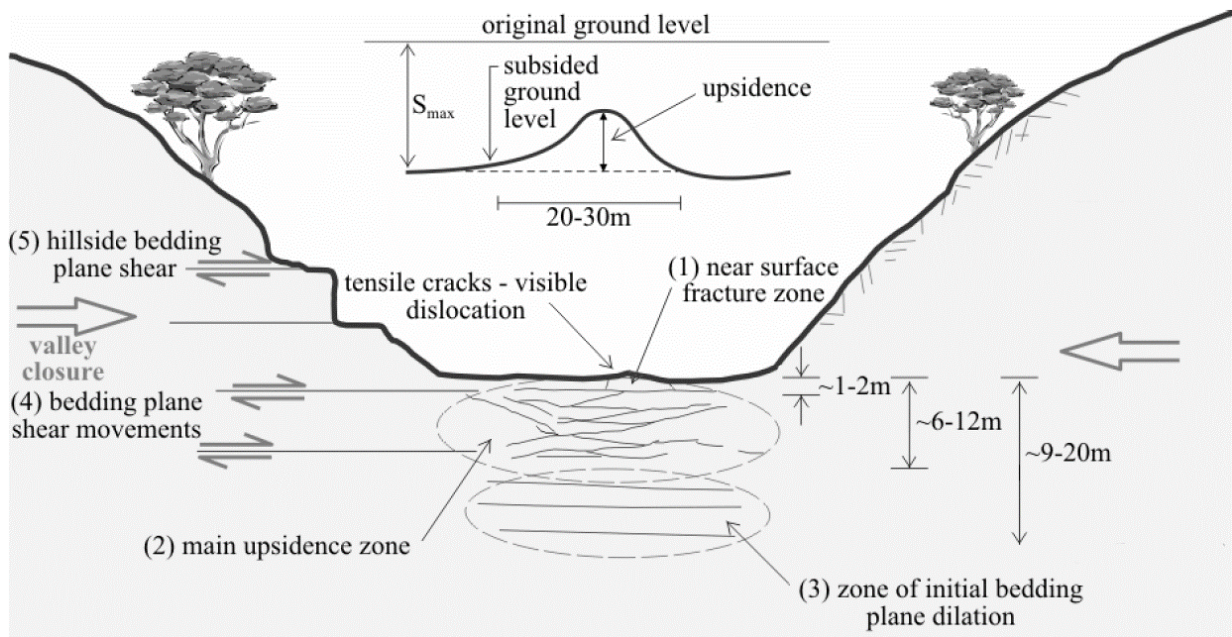
Affected areas of Myrtle Creek show zones of fracturing from the surface, down to approximately 6m – 12m below the surface. The fractures developed as low angle conjugate open fractures creating wedges that lift the surface causing localised upward movement of the creek bed. This process is referred to as upsidence (Mills, 2007). A diagram showing the distribution of fracturing due to valley closure is shown in Figure 2.

**Figure 2 Typical cross section showing nature of rock fracturing observed due to valley closure in river channels in the Southern Coalfields (Mills, 2007).**

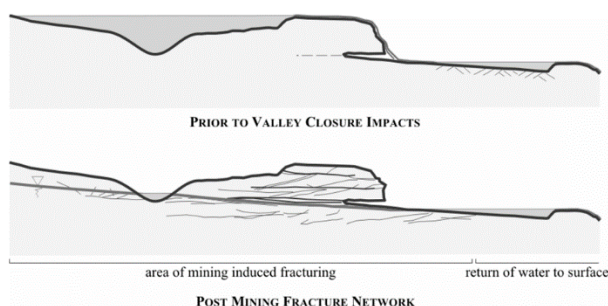
The induced fracturing at the base of the creeks has led to a decrease in surface water flow and an increase in subterranean water flow at affected areas of Myrtle Creek. Figure 3 illustrates the diversion of surface flow through the fracture network of the rock bar and the return to surface flow downstream away from the area affected by mining (Mills, 2007).

**Figure 3 Longitudinal section showing diversion of surface flow through the fracture network and return flow to the surface (Mills, 2007).**
